Sports Surfaces

Installation
Regeneration
Maintenance

Brochure

HB Sports Surfaces
Maintenance and Installation

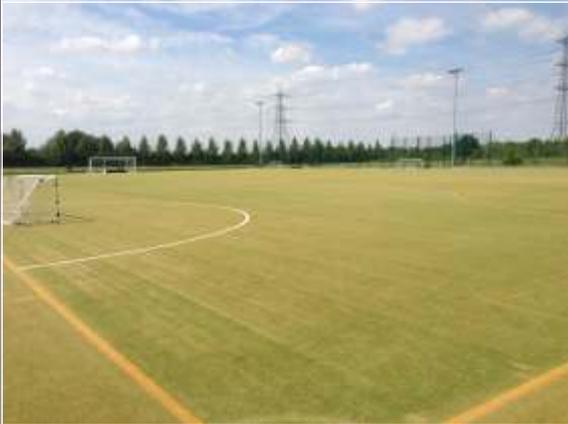
Sand Filled

Sand filled artificial sports surfaces have typically pile heights around 20 to 24mm, these surfaces require regular brushing.

It depends upon the usage the surface gets as to how regular it would require maintenance. Heavy usage of an artificial sand filled sports surface could mean it would require brushing weekly. In addition to this, the artificial surface will require chemical treatment and deep cleaning throughout its life.

If your sports surface has widespread contamination caused by incorrect maintenance then it may be necessary to completely remove the contaminated sand and replace it.

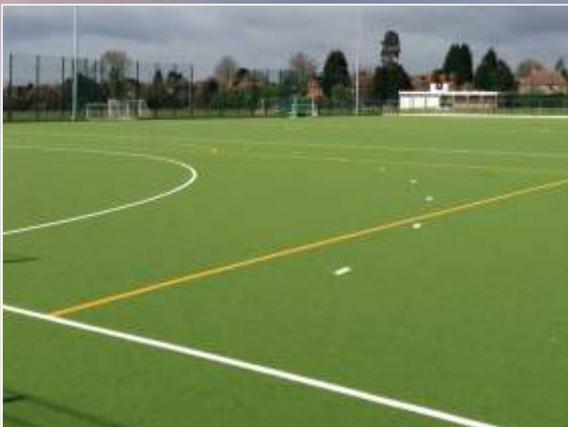
Sand Dressed Carpet Turf is a dense short pile that requires a fine sand infill.

This kind of Artificial Sport Turf is much greener in its appearance as they have more fibres exposed than a Sand Filled Turf.

These artificial surfaces usually have pile heights between 15 and 20mm. Sand dressed surfaces have less sand than the filled surfaces, this can result in considerably faster play characteristics.

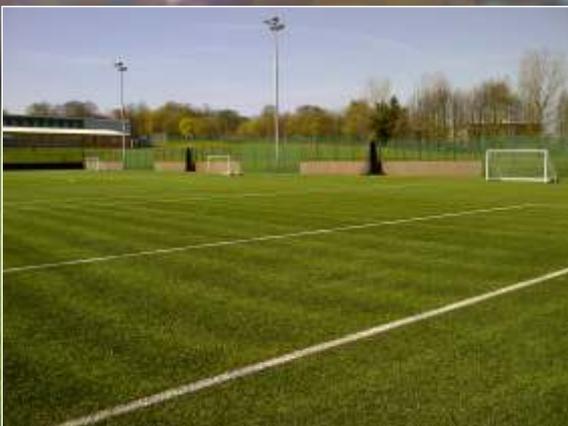
3G (3rd generation)

Third Generation Artificial Grass or 3G Artificial Grass not only has sand infill it also has a rubber crumb infill.

Fibres from 35mm to 65mm are supported by the rubber and sand infill levels; it is possible to adjust this infill level in order to produce optimum playing characteristics for particular games.

Generally they are used for football, but the shorter versions make excellent pitches for hockey practice and if a shock absorbent pad is installed underneath, it is perfect for rugby. To completely remove the contaminated sand and replace it.

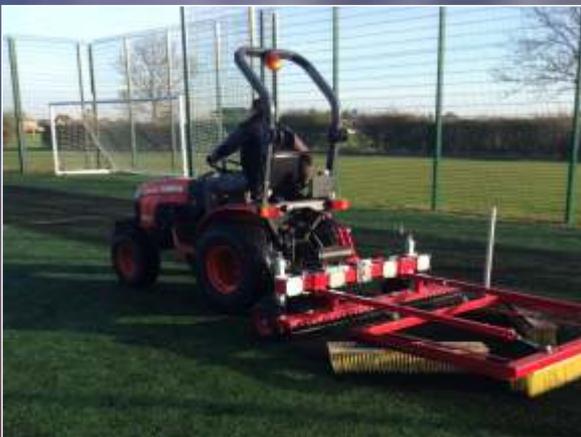
Regular drag brushing is an essential part of a maintenance programme to ensure the infill is distributed evenly and to reduce surface compaction.

Drag Brushing lifts the artificial carpet pile ensuring it is more responsive. Drag Brushing is carried out on sand and rubber infilled artificial turf. Where a sports facility is very well used then Drag Brushing is advised to be carried out weekly.

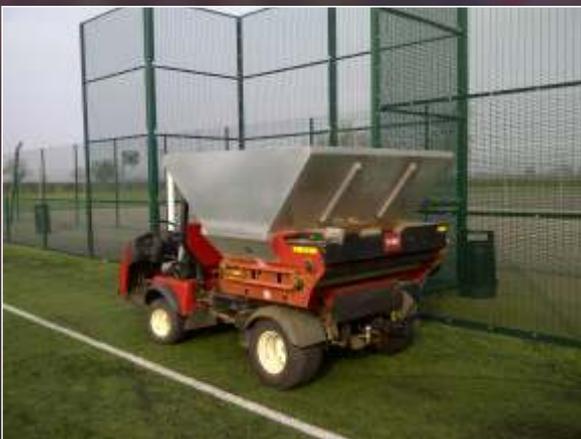
In-Fill Top Ups

Sand replacement and Surface Repairs may be required after a number of years as even sports surfaces that are regularly maintained can become compacted, in some cases debris can cause problems and this would result in poor drainage.

Areas which suffer excessive use ie: a penalty spots can after years deteriorate and the surface may deform causing poor play conditions. It is essential to keep the infill levels topped up to prevent this, as insufficient infill will not protect or support the yarn pile satisfactorily. If infill procedures are not carried out correctly it could lead to more costly maintenance costs in the future.

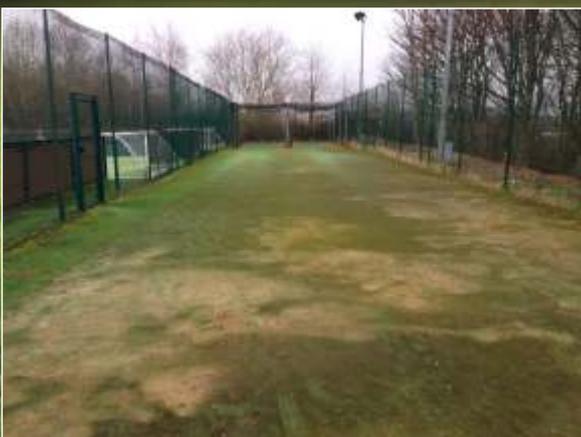
Moss Algae Control

Moss, Algae and weed growth is also prevented by the appliance of chemicals. These Chemicals require time to penetrate the surface in order to help detritus removal.

Algaecide which is injected deeply into a sports carpet will successfully remove any deep rooted algae. Vegetation contamination can pose a slip hazard and render your artificial sports surface dangerous. The regularity of such chemical treatments is dependent on the positioning of the artificial sports surface to such things as shade, damp areas, deciduous trees etc.

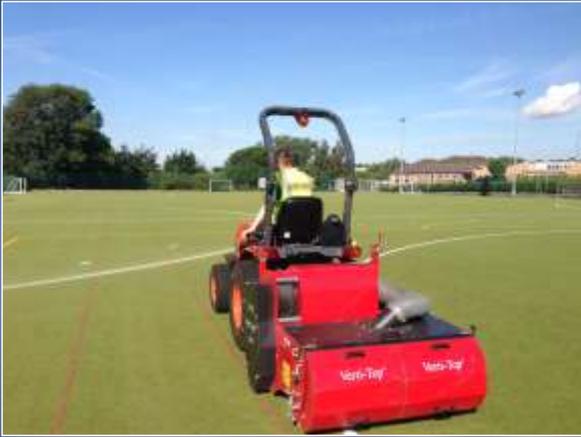
Regular Power Brushing of artificial sports grass helps to bed the sand into the fibres, moving the sand around also reduces moss and debris build-up within the fibres.

Power Sweeping is used on all types of artificial grass surfaces. Rotary power brushes lift the pile and filter the top infill layer. Power Brushing reduces surface contamination from algae, moss etc.

Regular brushing at advised intervals can ensure you get the best performance out of your surface and give it that essential long lifespan.

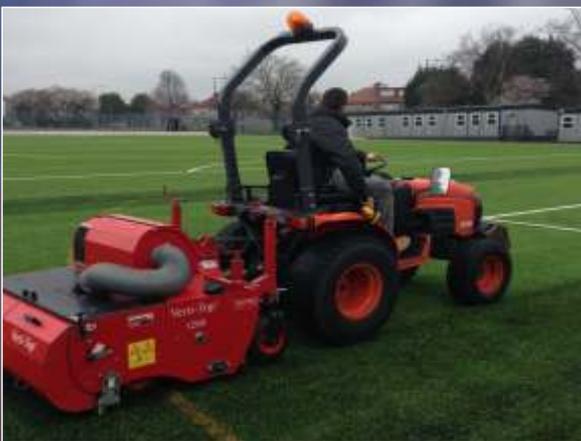
Deep Clean / Decompaction

Over the year moss, dirt and debris build up and affect the colour and the performance.

Our powerful deep cleaning service revitalises your synthetic sports surface by decompacting and filtering the sports surface infill, ensuring you continue to get the best performance out of your surface.

A deep clean is advisable in these circumstances as Drag Brushing, Sweeping and Power Brushing are often not invasive enough to tackle these problems, especially on older sports surfaces.

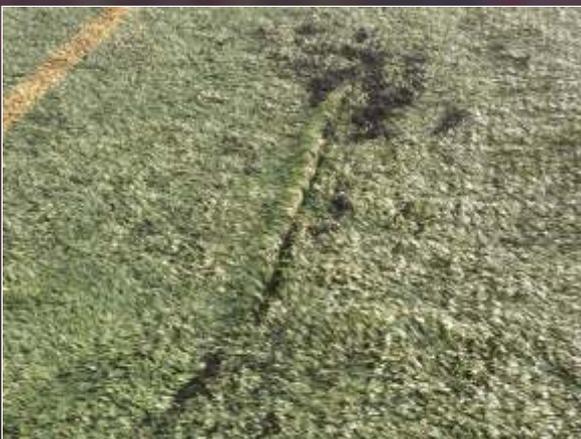
Surface Repair

High wear areas of artificial sports surfaces often require attention, areas around goals, penalty spots etc. can become badly affected and need repair.

Adhesives can break down and seams and lines may need to be replaced. Rain and frost on older sports surfaces can penetrate under the artificial carpet; this action can cause adhesives to break down and seams to fail. Worn areas can be cut out and patched; sub-surfaces may also require attention, especially those which may be found to be around collapsed drains.

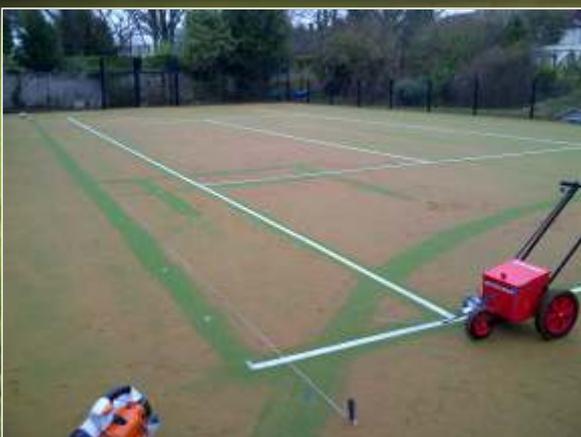
Line Marking

HB Sports Maintenance offer line marking services for all types of synthetic sports surfaces and can professionally line all pitch, court and track-based sports. We recommend that line markings are renewed twice a year on sand-filled and sand-dressed sports surfaces.

As with any painted surface painted sports lines on artificial surfaces will need to be re-painted as they do wear off and fade over time. Clear line markings make an artificial surface more pleasurable to play on. Sport lines tend to be the first points affected by the build up of algae and moss etc, so it is vitally important to keep them maintained.

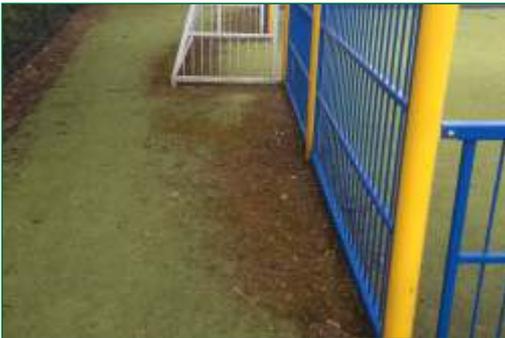
Algae, moss and weeds can build up on surfaces where such vegetation has been allowed to grow and spread. If they are left for a period unchecked, this detritus will inevitably lead to infill contamination and this in time will hinder the play performance of your artificial sports surface.

The solution to this problem is to undertake regular maintenance, in order to control vegetation contamination. Deep Cleaning and Power Sweeping will help to stay on top of the problem.

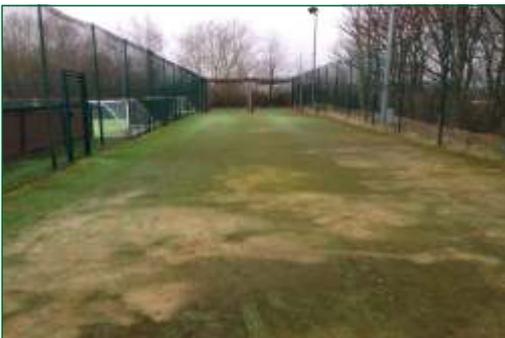
Flooding

Insufficient drainage causes pooling on artificial sports surfaces. A seriously slippery surface is the result of a neglected sports pitch. Routine maintenance will eliminate detritus build up and prevent contamination of the sand underneath. A good maintenance programme entailing vegetation control, deep cleaning and Power Sweeping will ensure that the artificial carpet is able to drain well so good play performance is not lost.

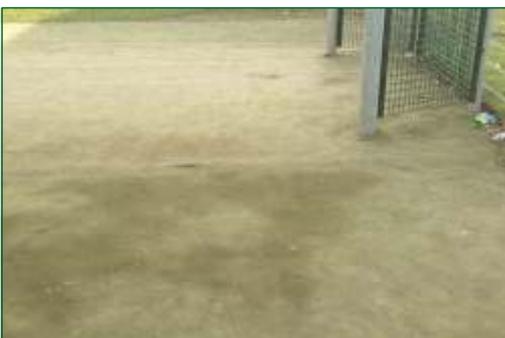
Staining can occur when mud or other contaminants are brought onto the playing surface and not properly cleaned off, water can pool on the artificial sports surface leaving debris, this can lead to staining and present a slip hazard. A professional artificial sports surface maintenance programme can ensure your artificial surface is free from stains.

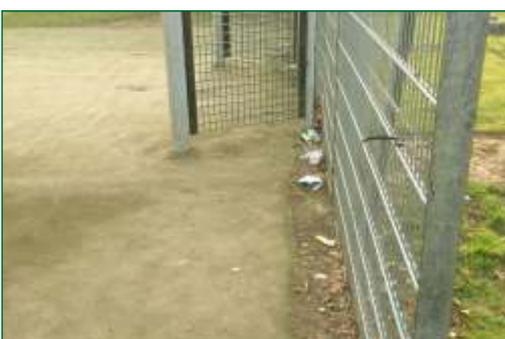
Sand Build Up

Sand build up can occur around the edges of the artificial sports surface if it is not properly maintained. A professional maintenance programme can help to ensure there is no sand build-up and that the base in-fill consistency across the surface is equal. Regular professional brushing will help to keep this problem at bay, soon as possible before the artificial sports carpet is too badly damaged.

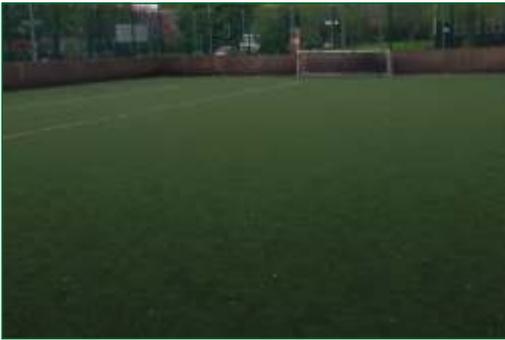
Infill Shortage

This problem occurs if the sports surface has not been properly maintained. The sand infill can reduce or be pushed to the edges of the surface with repeated play so without the protection of the infill, the surface can become worn and damaged more easily. The artificial sports surface play performance will be adversely affected. A maintenance programme will ensure the artificial surface is properly in-filled and top-up where appropriate.

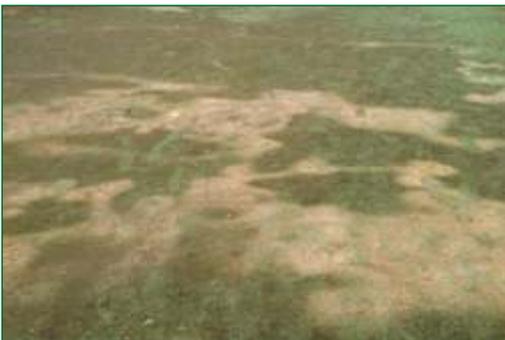
Infill Compaction

Infill compaction can adversely affect the play performance of the artificial grass sports surface, this is because the fill is forced together overtime through use as well as prevailing weather conditions. This compaction of infill prevents water passing through and results in standing/pooling water. Poor drainage results in loss of use and promotes moss and algae growth on the artificial surface. The sports ground can then become slippery and hard. The Artificial Piles' tip can become unsupported so play characteristics are altered considerably.

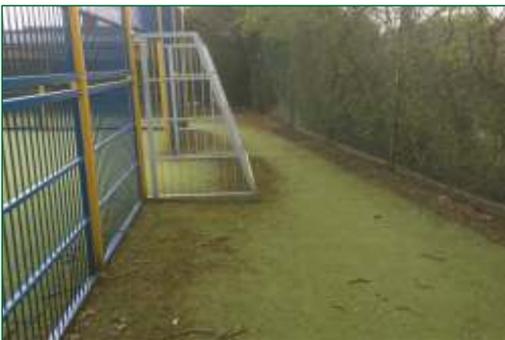
Infill Contamination

Vegetation, moss, algae, spores, carpet fibres, skin and ball fluff etc can all fill the void between the infill particles. The sub-surface becomes blocked and upper levels rendered sealed, preventing good drainage. The surface will then be prone to flooding and standing pools of water. The sports carpet will become slippery as algae growth prevails and just as with infill compaction the contamination of the infill will adversely affect play characteristics.

A good maintenance programme can help to prevent infill contamination as a professional clean would keep debris to a minimum.

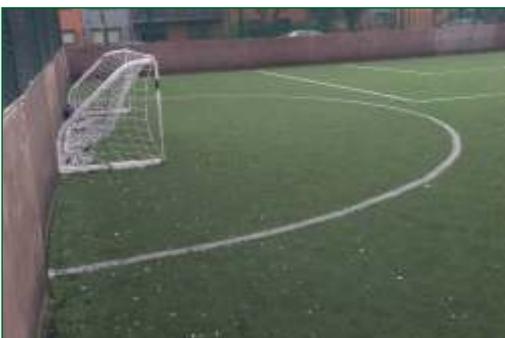
Pile Fold

Infill particles can compact together in areas of high wear (around goal mouths, base lines, entrances etc).

If this compaction of the sub-base is left untreated then the artificial carpet pile can tend to bend over or fold due to being unsupported. Traction is then lost and the sport surface can become slippery. HB's professional maintenance programme can help to prevent 'Pile Fold' as compacted infill would be treated /replaced and new infill would be evenly distributed.

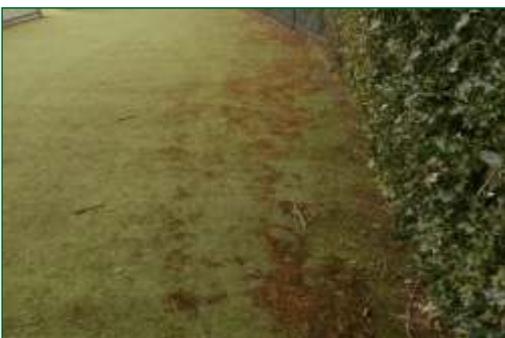
Heavy Vegetation

All forms of vegetation and foreign debris on an artificial sports surface is not good news, it can cause serious damage to the carpet and play performance would be badly affected. Debris and vegetation control would be undertaken during our comprehensive maintenance programme, chemicals are applied to eliminate the growth of moss, algae, weeds etc. How regular this treatment would have to be carried out, is dependent on the type of surface and its positioning in terms of shade, deciduous trees etc.
